# T1 SOFT ROLL UP COVER

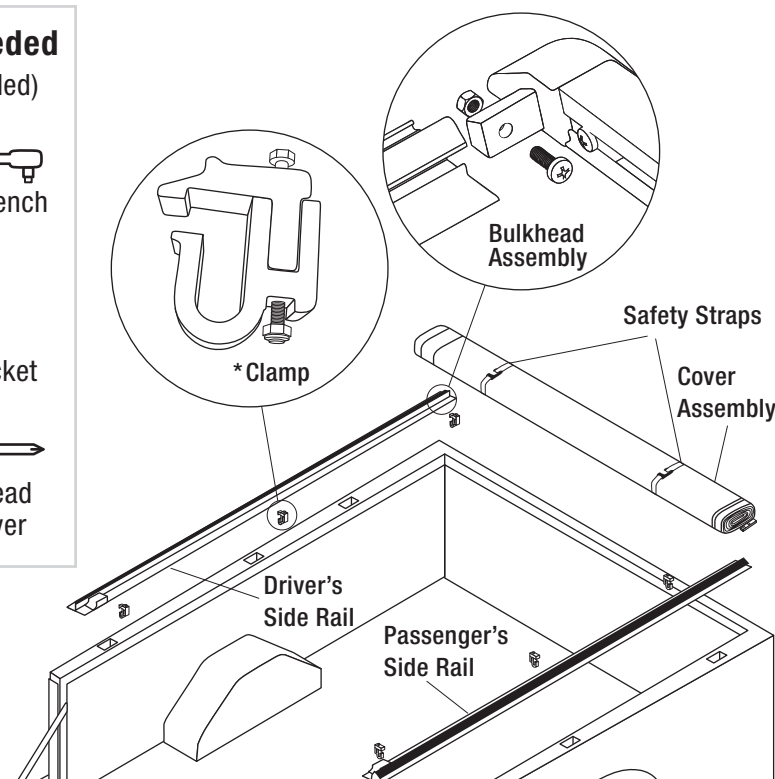
### Tools Needed

Ratchet Wrench

10mm Socket

Phillips Head Screwdriver

\* Quantity and shape of clamps may vary by different vehicles. Please refer to the checklist.

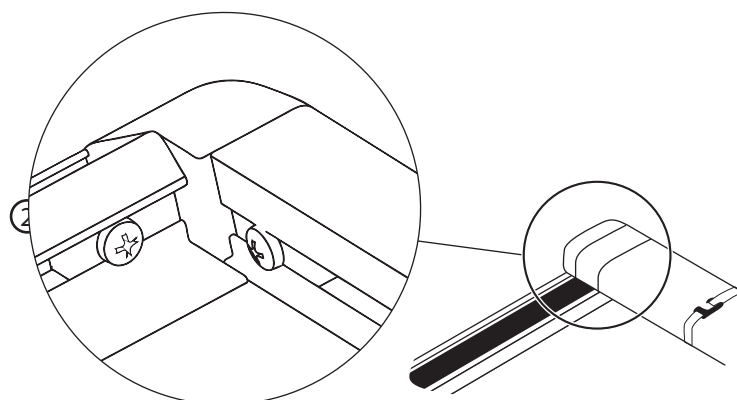
## STEP 1

### Installing Cover Assembly

Place cover assembly on the front truck rail, loosen the screw in bulkhead assembly, slide the side rail into the channel, then re-tighten the screw to secure the bulkhead assembly. Follow the same procedure for the other side.

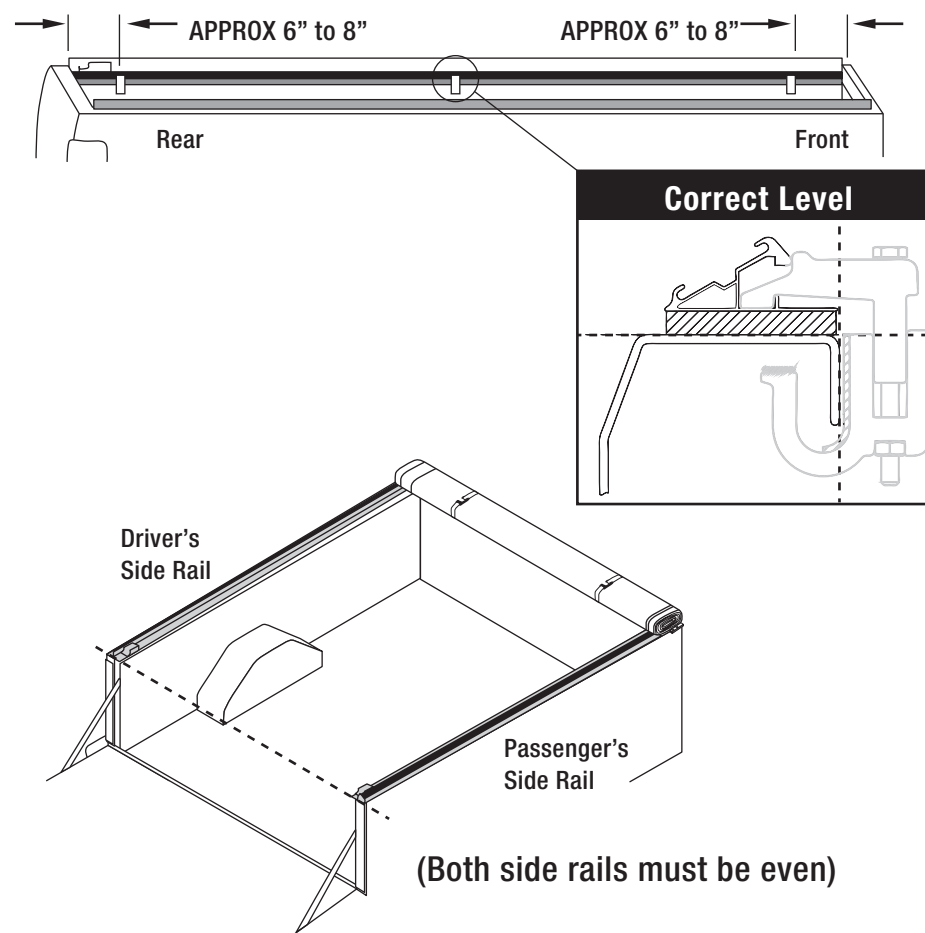
## STEP 2

### Positioning Side Rails

Align the inside edge of the side rail to the inner edge of the truck bed rail. Then, leaving approximately 6"-8" of space on each end, evenly space the clamps provided along the side rail. Make sure the side rails are placed so that the distance from the tailgate is equal on both sides.

- It's suggested when unlatching the cover, to use one hand to push down on the cover while pulling on the latch cable on either side for an easier release, this will reduce the wear and tear of the latching system.
- Adjust the tension plate towards the bulk-head if the cover seems too tight.
- Check **STEP 2**, make sure the side rails are placed so that the distance from the tailgate is equal on both sides.

- Make sure side rails are positioned properly, not too far from the tailgate, check **STEP 2**.
- Move the whole cover assembly towards the tailgate, while making sure it's properly sealed at the front.

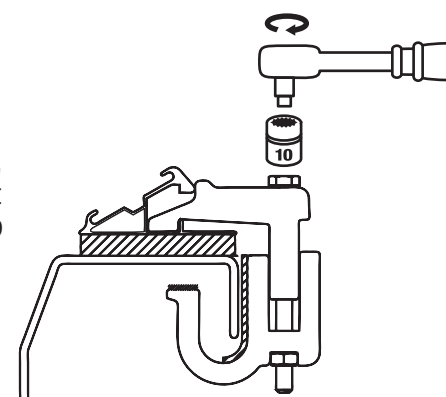
## STEP 3

### Tightening Clamps

Do not tighten clamps until all clamps and side rails are in proper position. (Refer to Step 5)

NOTE: For Over-the-Bedrail bed liner, small 2"x4" holes will need to be cut on the liner in order to fasten the clamp

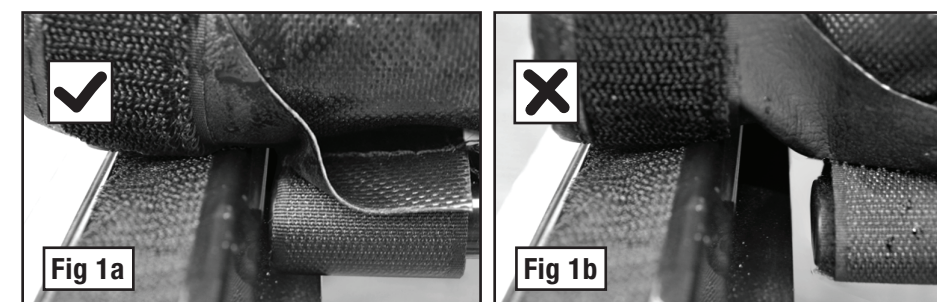
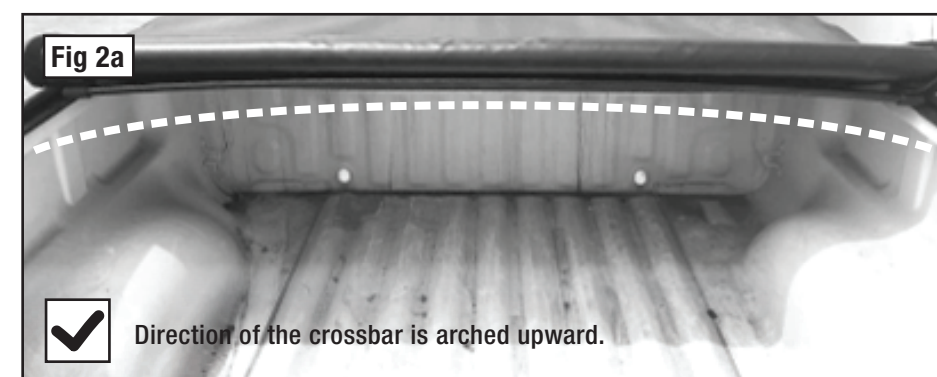
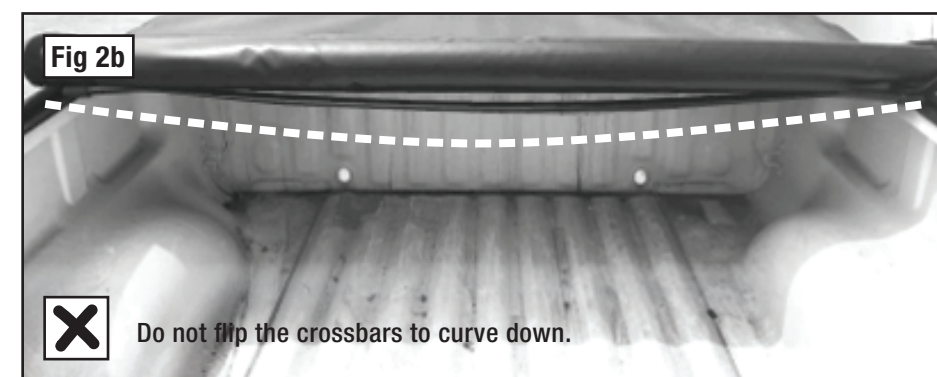
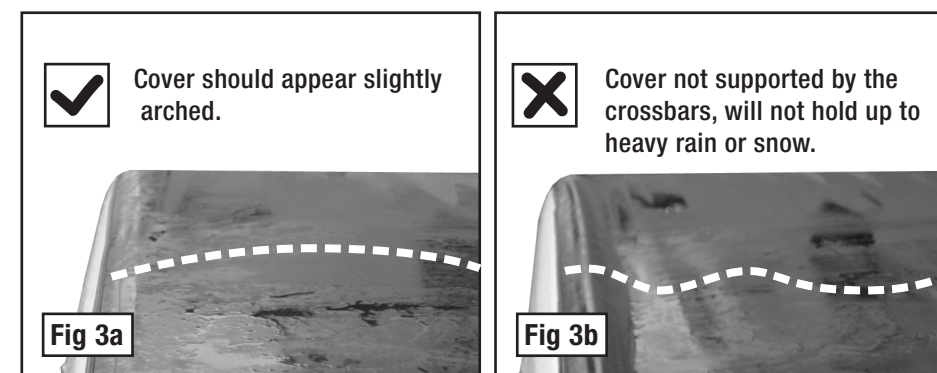
## STEP 4

### Rolling down the cover

When rolling down the cover, make sure the ends of the crossbar are resting on the side rails and the direction of the crossbar is arched upward. (Fig 1a, Fig 2a, Fig 3a).

CAUTION: Incorrect position of the crossbar; this will cause water to pool in the middle (Fig 1b, Fig 2b, Fig 3b).

- Cover should appear slightly arched as in **Fig 3a**; make sure the ends of the crossbars are resting on the side rails (**Fig 1a, Fig 2a**).

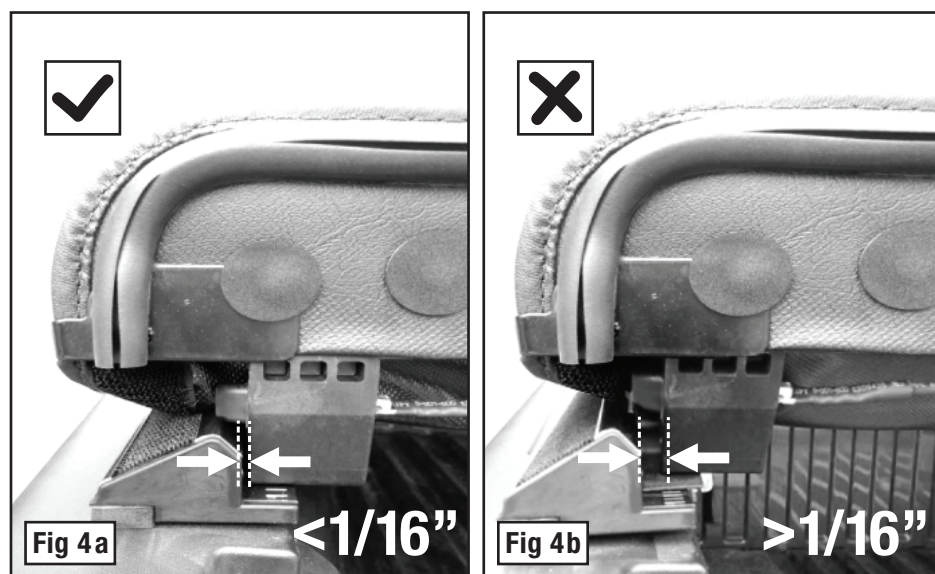
## STEP 5

### Latching and Unlatching the cover

Please ensure the gap between the locking clip and the side rail at end of the tailgate is less than 1/16" for proper security of the cover (Fig 4a). Make sure to adjust the position of the side rails if necessary.

CAUTION: The cover will not lock securely if the gap is greater than 1/16"(Fig 4b).

- Check **Fig 4a** to see if the horizontal gap between the locking clip and the side rail is under 1/16 inches.
- Make sure cover is latched down prior to closing the tailgate.
- Check if the cover is properly attached to the Velcro strips on the side rails; cover must be latched down first prior to sealing the Velcro strips on both sides.
- Check **STEP 2**, make sure the side rails are placed so that the distance from the tailgate is equal on both sides.

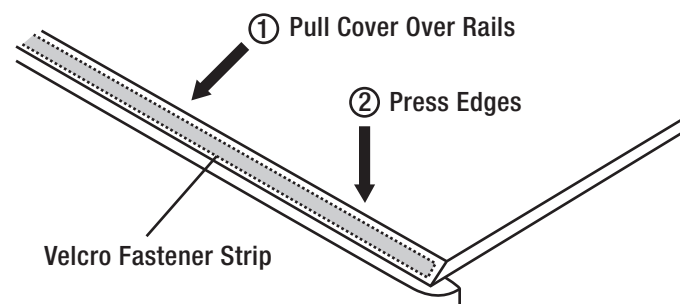
## STEP 6

### Secure Velcro Fastener

Pull cover horizontally over the side rails and press down the edge to secure the Velcro fastener. This step should be done after the cover is latched down.

NOTE: Cover must be latched down prior to closing the tailgate.

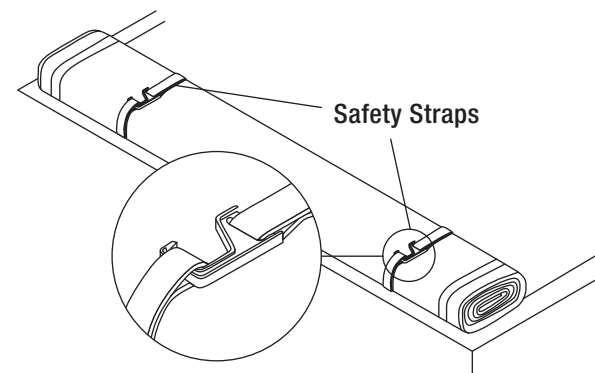
### Open the Cover

Roll the cover towards the cab and secure by hooking the safety strap to the front loop on both sides.

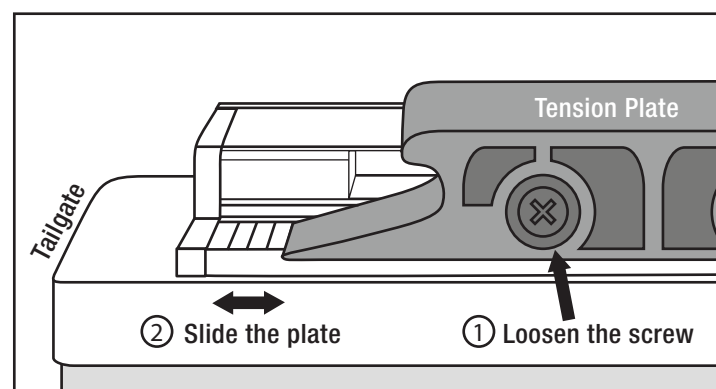
### Tension Control System

Depending on the weather condition it may be necessary to adjust the tension control system. To adjust, loosen the screw on the tension plate, then the tension plate can be slid back and forth.

- Only move the tension plate one increment at a time.
- Each increment will give 1/8inches of tension adjustment.
