# GM8427

2011-2015 CHEVROLET/GMC,  
SILVERADO/ SIERRA, HD2500-3500,  
DURAMAX, DOWN PIPE

# MBRP®

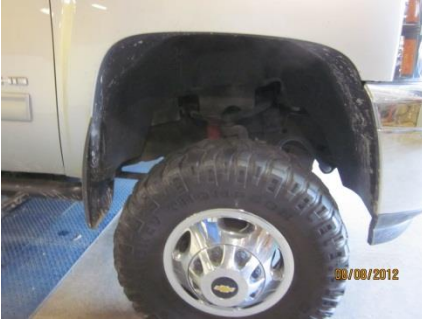
**Figure 1**

1. Remove the passenger side inner fender. **See Figure 1.**  
Note: we also removed the Grille Assembly to prevent damage to it during the removal or installation of the down pipe.

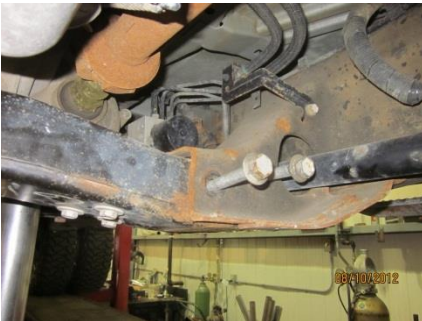
**Figure 3**

3. The front pipe needs to be temporarily removed. Carefully disconnect all sensors and loosen the four flange nuts on the rearward part of the front pipe. The transmission cross-member will need to be temporarily dropped to remove the front pipe. Remember to support the transmission with a block or jack stand while doing the transmission cross member is removal. **See Figure 3.**

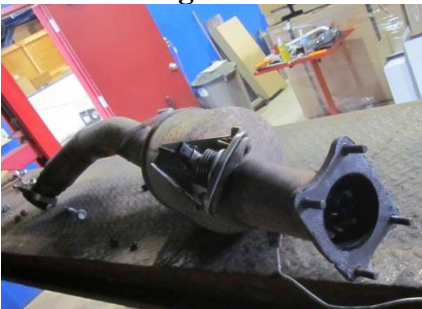
4. The front pipe also has a hanger mounted to the transmission that will also have to be removed. **Figure 4** shows the front pipe assembly removed.
5. The heat shield on top of the turbo will need to be removed. There is also a shield on the back of the down pipe. It runs along the firewall that needs to be removed. The 2 stock sensors on the top of the down pipe need to be carefully removed. Set the sensors aside and save for the installation. The stock V-Band clamp can be removed save for the installation. From the underside of the vehicle carefully slide the stock down pipe out between the frame and transmission.

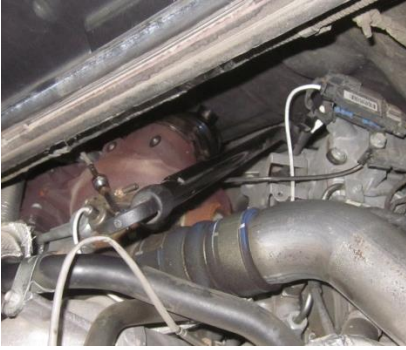
**Figure 6**

1. Start the install by sliding the **Down Pipe** up from the underside of the vehicle or the passenger side wheel well. Mate the flange up to the turbo and install the V-Band clamp at the turbo. Leave the clamp loose enough for some rotation.

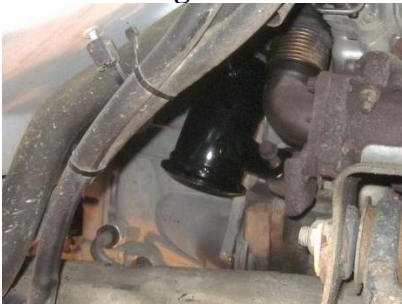
**Figure 8**

3. Install the stock sensors into the **Down Pipe**. One is located along the lower section of the **Down Pipe** (Refer to Figure 8.) The other two sensors are located closer to the turbo.

4. The front pipe can then be reinstalled using the stock hardware and V-Band clamp. Refer to Figures 8 & 9.
5. Reinstall the exhaust hanger to the transmission cross member. Reinstall the transmission cross member. Reconnect all the sensors to the front pipe.

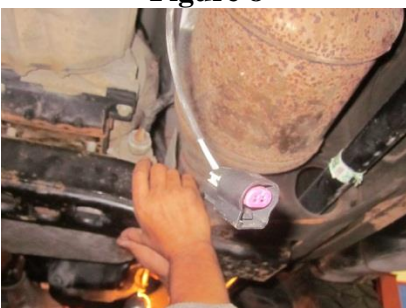
**Figure 10**

6. Reinstall the passenger side inner fender.
7. Reinstall the turbo heat shield. Refer to Figure 10. Check along the exhaust to make sure all connections and tightened. Check along the whole length of the exhaust system to ensure that there is adequate clearance around the spare tire, fuel and brake lines or any wiring. If any interference is detected relocate or adjust.
