TYGER®

T1 | SOFT ROLL UP Tonneau Cover

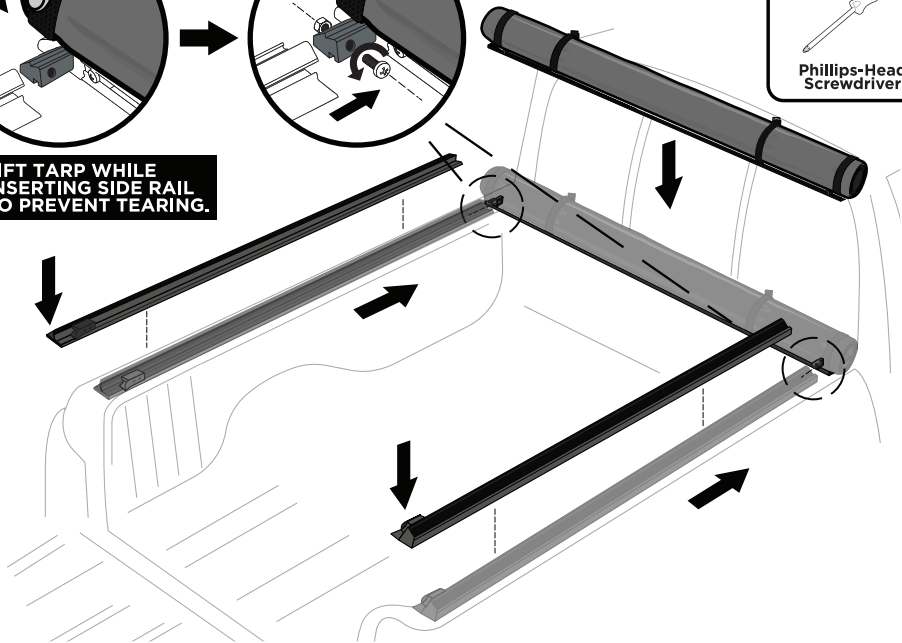
1 ASSEMBLING COVER

- PLACE COVER ASSEMBLY ON FRONT TRUCK BED RAIL AGAINST THE CAB.
- LOOSEN THE SCREW IN BULKHEAD ASSEMBLY ON BOTH SIDES, THEN SLIDE IN THE SIDE RAILS.
- REINSTALL AND TIGHTEN SCREWS TO ATTACH SIDE RAILS TO COVER ASSEMBLY

LIFT TARP WHILE INSERTING SIDE RAIL TO PREVENT TEARING.

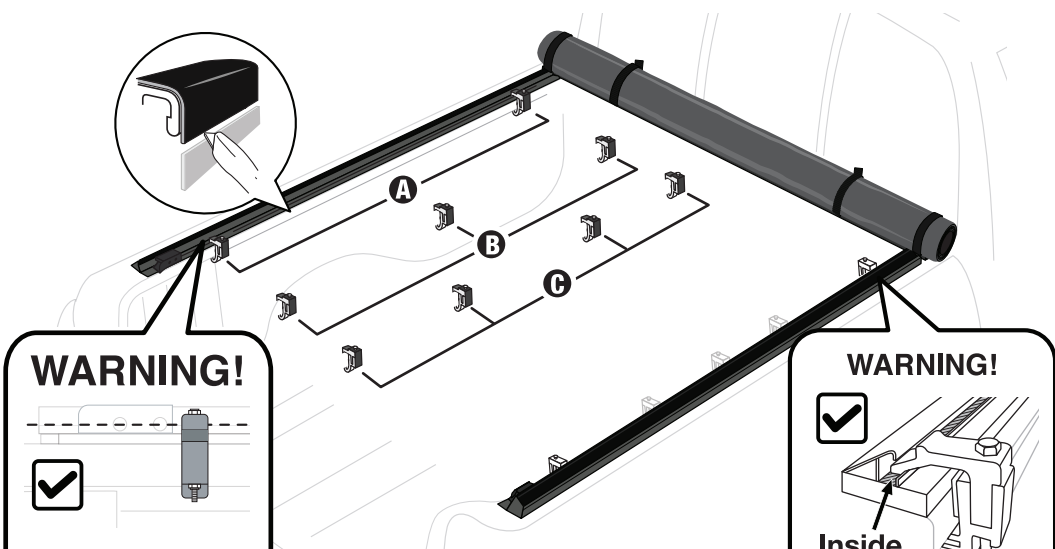
2 POSITIONING SIDE RAILS

- THE NUMBER OF CLAMPS EQUIPPED ON THIS BED COVER IS SPECIFIC TO THE MODEL AND BED SIZE. CONFIRM THE NUMBER (4/6/8) OF CLAMPS INSIDE THE HARDWARE PACKAGE.
- THEN EVENLY PLACE THE SUPPLIED CLAMPS ALONG THE SIDE RAILS ACCORDING TO THE POSITIONAL CONFIGURATION A/B/C BASED ON THE # OF CLAMPS.
- ATTACH THE CLAMPS TO THE SIDE RAIL AND THE TRUCK BED RAILS. DO NOT TIGHTEN CLAMPS UNTIL COVER IS PROPERLY FITTED.

A

4 CLAMPS
B

6 CLAMPS
C

8 CLAMPS

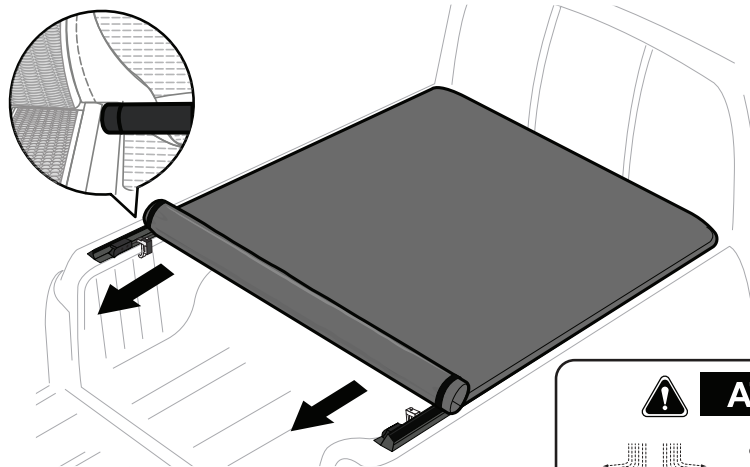
3 ROLLING DOWN THE COVER

- UNHOOK THE SAFETY STRAPS.
- MAKE SURE THE ENDS OF THE CROSSBAR ARE RESTING ON THE SIDE RAILS AND THE DIRECTION OF THE CROSSBAR IS ARCHED UPWARD.

DO NOT OFFSET THE CROSSBAR OFF THE SIDE RAILS !

Horizontal crossbars are arched by default to help with water drainage. Make sure arched side is up during installation. Incorrect positioning of the crossbar will cause water to pool.

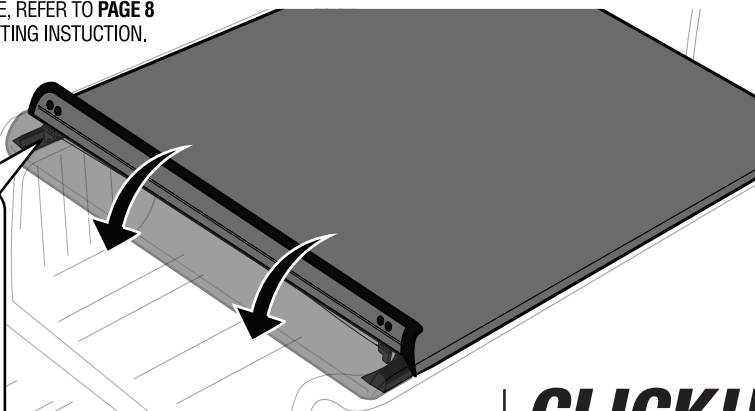
4 LATCHING THE COVER

- PUSH DOWN ON THE END OF COVER TO CLOSE.
- COVER MUST BE LATCHED DOWN PRIOR TO CLOSING THE TAILGATE.

In Channel

NOT In Channel

LATCH HEAD THAT IS OUT OF POSITION CAN CAUSE DAMAGE TO THE CHANNEL.

YOU SHOULD HEAR A CLICKING SOUND WHEN CLOSING THE COVER TO INDICATE THE COVER IS PROPERLY LATCHING DOWN.

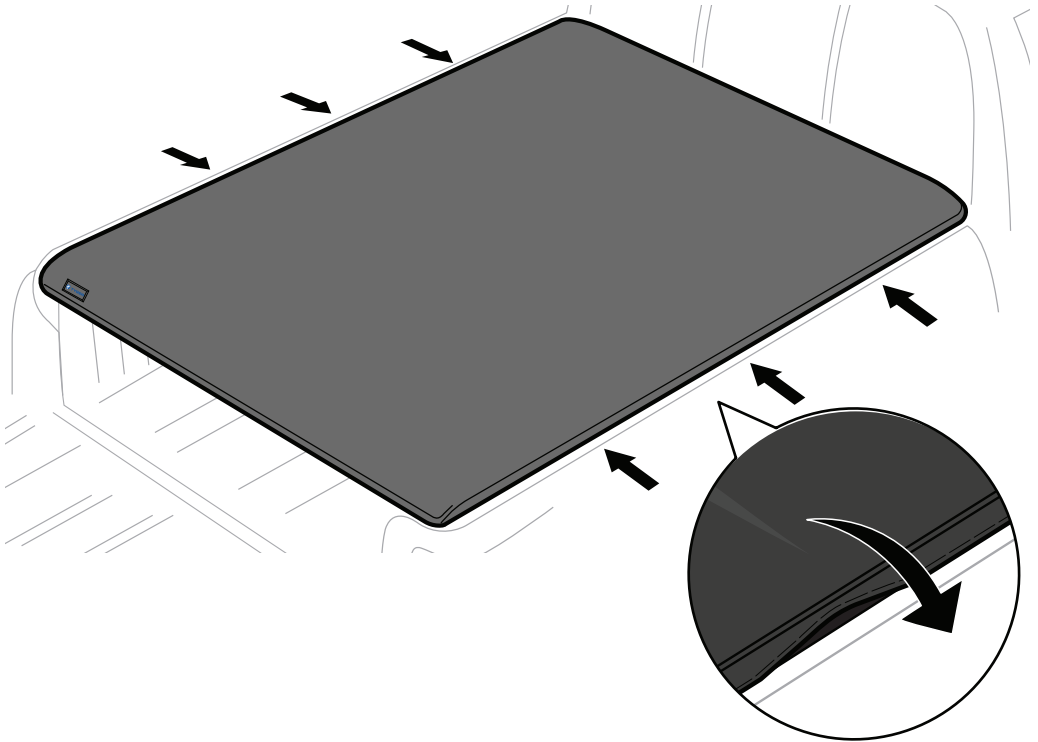
FINISHING THE INSTALLATION

- GENTLY PULL ON BOTH SIDES OF THE COVER. PRESS ALONG THE EDGES TO SECURE THE VELCRO.

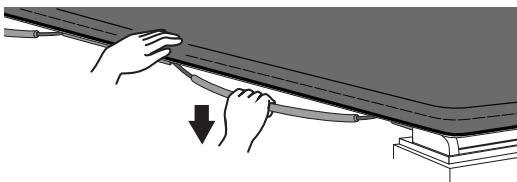
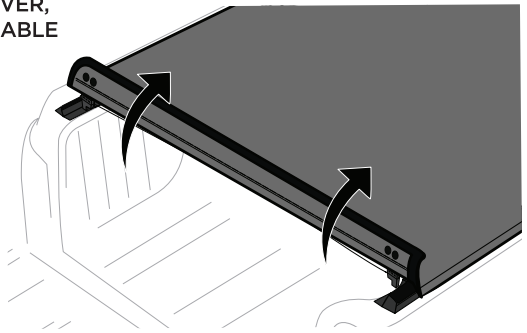
UNLATCHING THE COVER

- PUSH DOWN ON THE END OF THE COVER, PULL ON EITHER SIDE OF THE LATCH CABLE TO UNLATCH THE COVER.

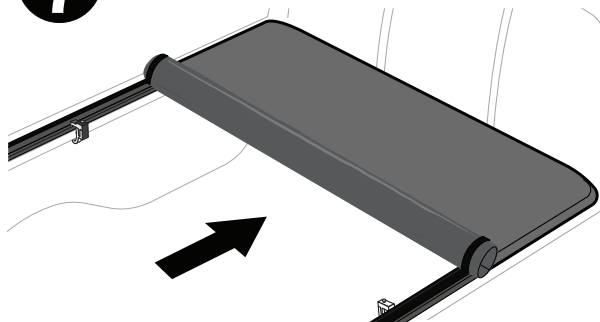
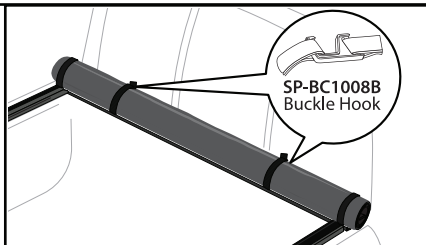
7 ROLLING UP THE COVER

- MAKE SURE THE COVER IS FREE OF ANY DEBRIS BEFORE ROLLING UP THE COVER. SAFETY STRAPS MUST BE SECURED BEFORE DRIVING AFTER YOU ROLLED UP THE COVER.

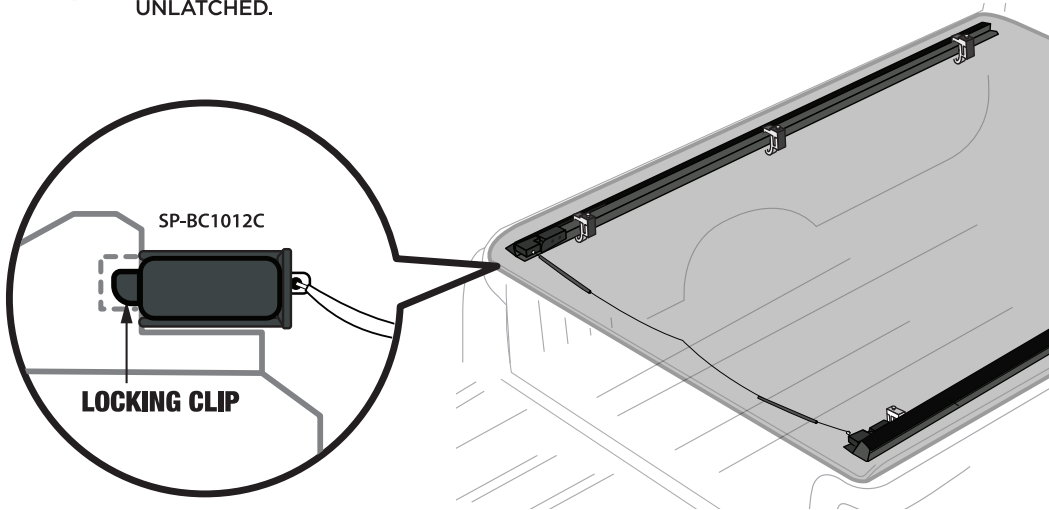
9

- MAKE SURE THE LOCKING CLIP ON BOTH SIDES ARE COMPLETELY INSERTED INTO THE CHANNEL ON THE SIDE RAILS TO AVOID END OF THE COVER BECOMING UNLATCHED.

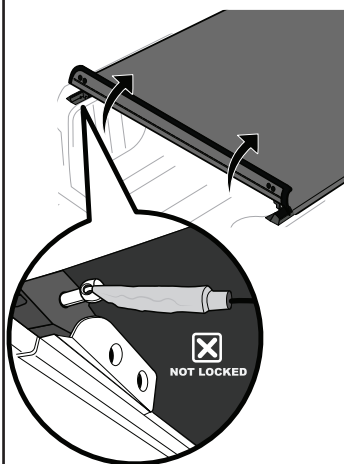
10

- IF COVER DOESN'T STAY CLOSED AND YOU FIND THE LOCKING CLIP IS NOT FULLY INSERTED.

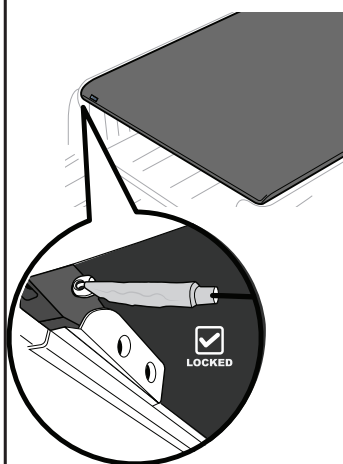
12

- TRY MOVING THE TENSION PLATE TOWARDS THE TAILGATE ON BOTH SIDES, ONE INCREMENT AT A TIME.

- MAKE SURE THE LOCKING CLIP ON BOTH SIDES ARE INSERTED INTO THE CHANNEL ON THE SIDE RAILS.
